Re: FY 20 Guidelines for Brownfields Assessment Grants

NARRATIVE INFORMATION SHEET AND ATTACHMENT

FORT LYON FACILITY **30999 COUNTY ROAD 15** LAS ANIMAS, BENT COUTY, COLORADO

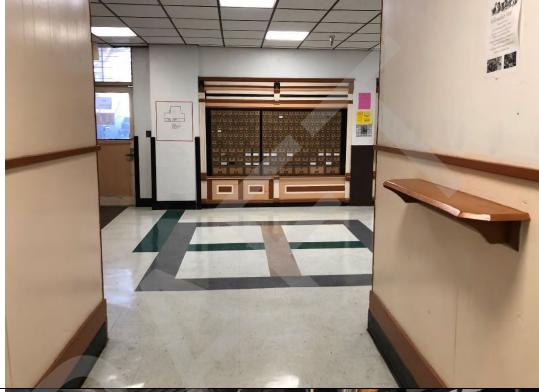
Photo No. 4

Black mastic present below these floor tiles in the basement of Building 3 has asbestos.

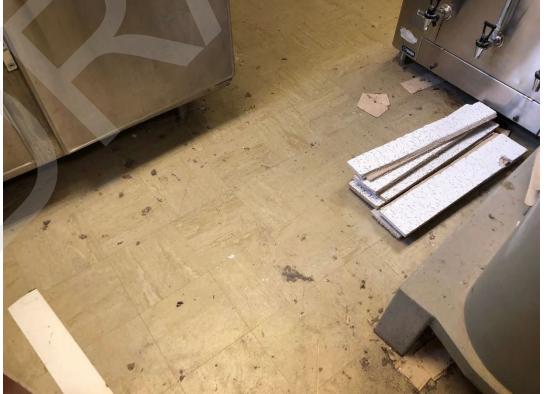
Asbestos is present in the floor tiles in a room in the basement of Building 3.

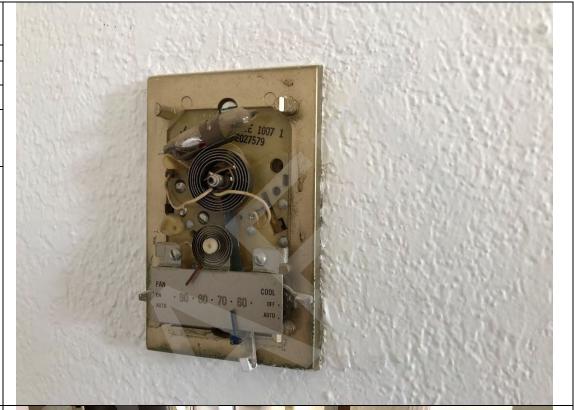
Mercury thermostat switch observed on the 2nd floor of Building 3.

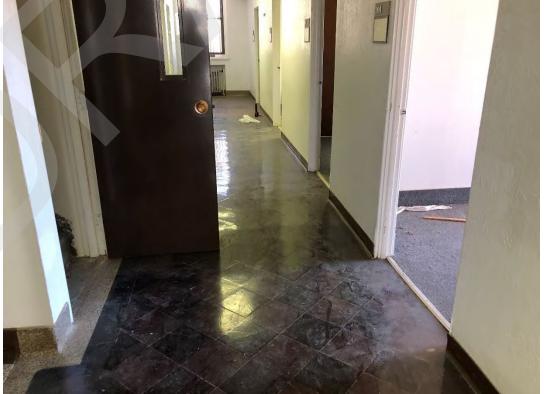
Asbestos present in floor tiles, mastic, and drywall compound on the 2nd floor of Building 3.

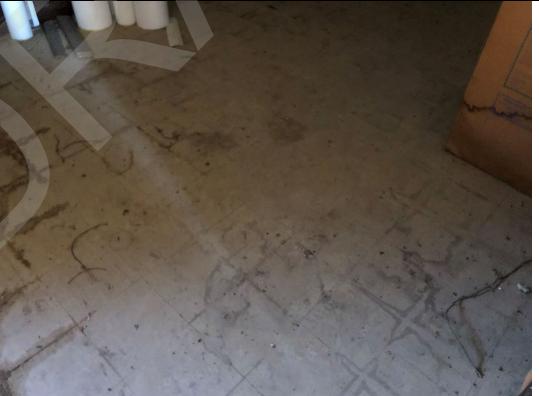
Asbestos present in floor tiles on the lower level of Building 17.

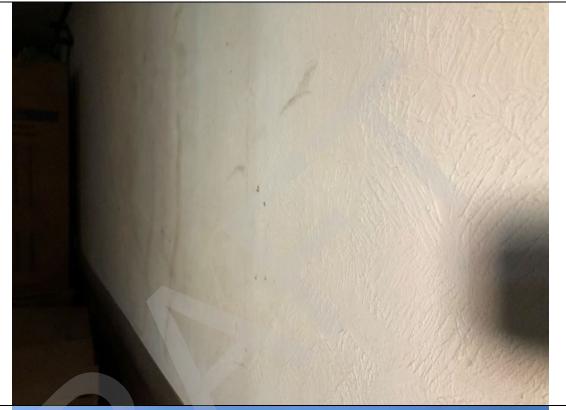
Asbestos present in this drywall texture on the lower level of Building 17.

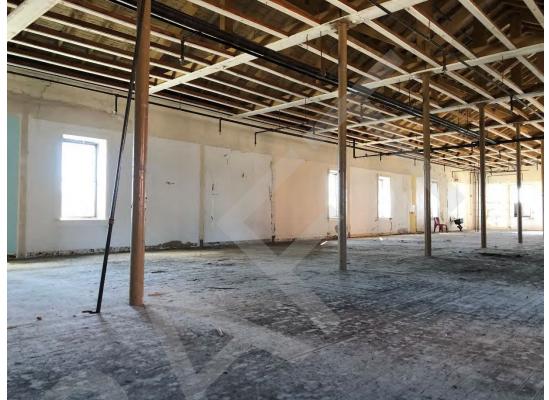
Asbestos is present in the topcoat of the plaster on the 2nd floor of Building 19.

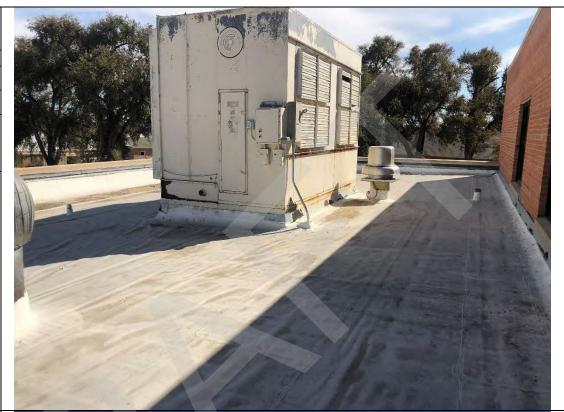
Asbestos present in duct tape and roofing sealant on the roof of Building 37.

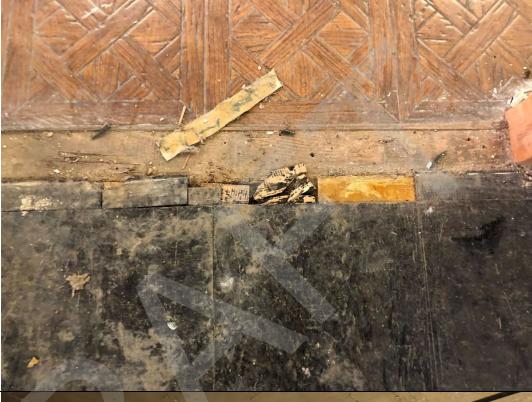
Asbestos present in floor tile and mastic and linoleum in central portion of Building 201.

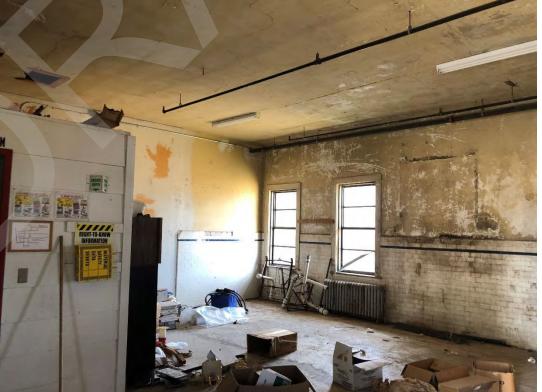
Drywall in the northern room of Building 201 has asbestos compounds present.

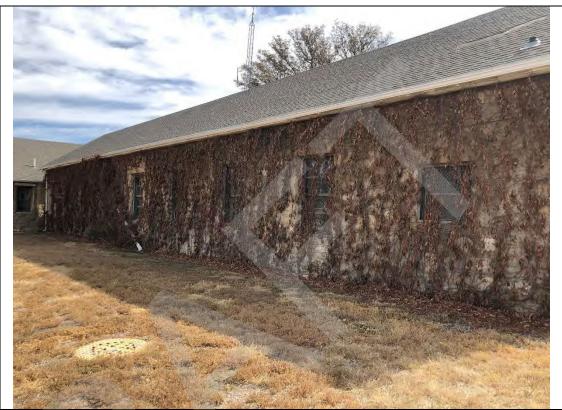
Window caulking on Building 201 has asbestos present.

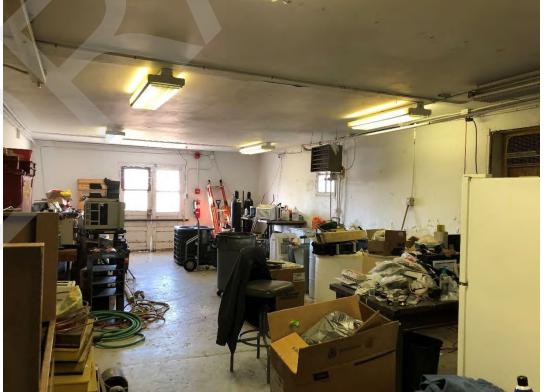
Drywall in this room of Building 221 has asbestos compounds present.

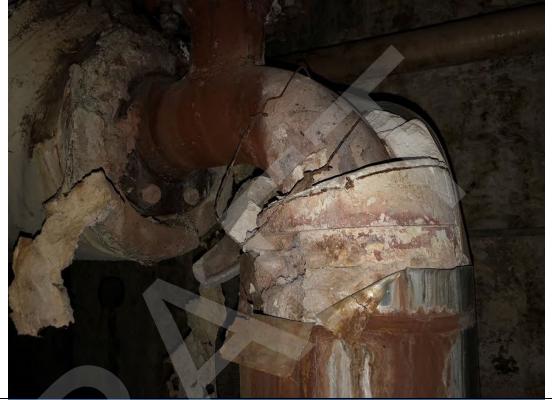
Pipe insulation throughout Building 221 and steam tunnels is plaster and is not asbestos.

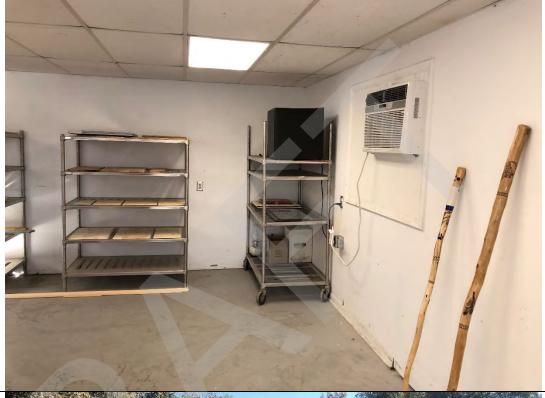
Asbestos is present in the drywall compound of Building 221.

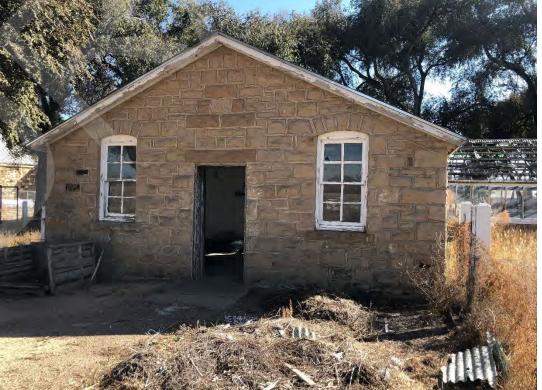
Asbestos is present in window caulking on the exterior of Building 246.
